***Alder Specialist Building Surveyors Ltd***

November 19<sup>th</sup> 2020

Our Ref: 6246/d

**Re: West Eldon House, Kiltarlity**

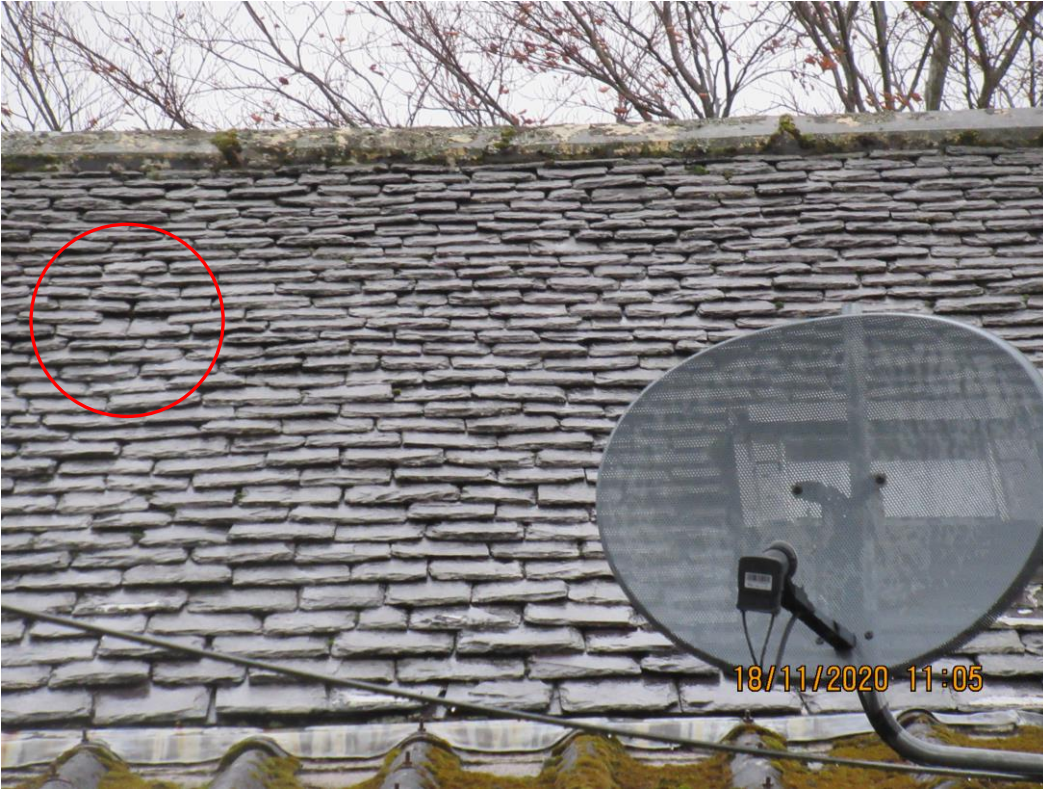
*Missing slate*

We would recommend that the client sees to these defects as a matter of course.

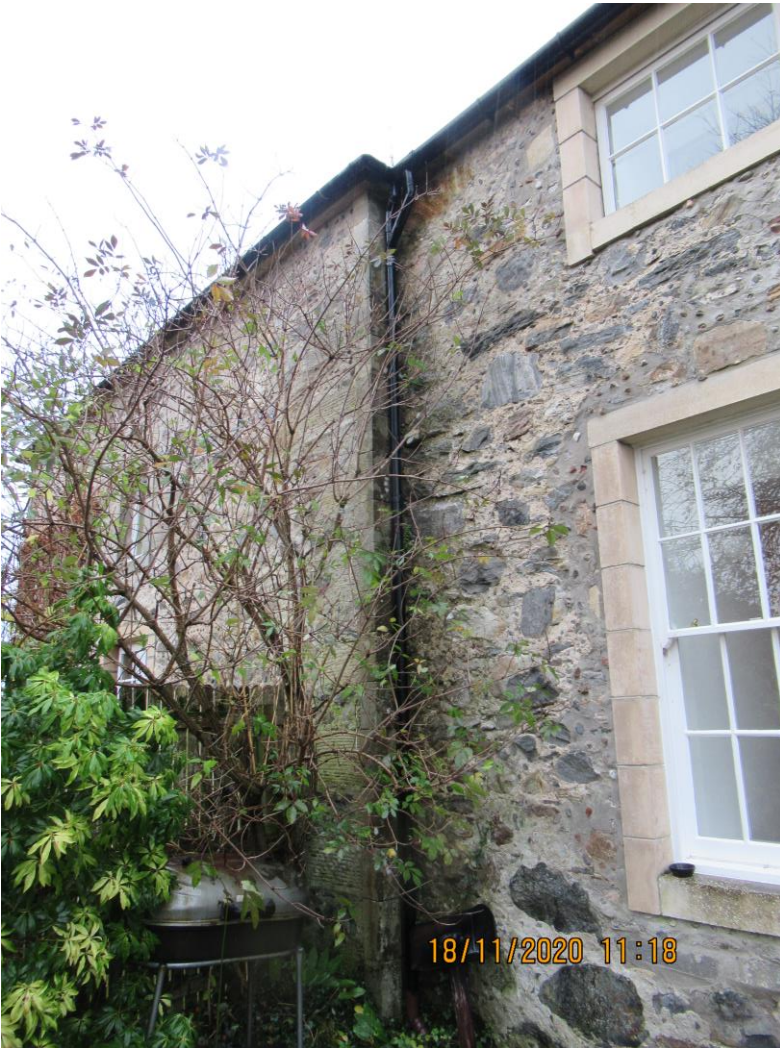
*The down pipe to the left of the front door was overflowing from the top and you will notice the beginning of algae staining on the masonry in behind the pipe. Possibly just needing to be cleaned out.*

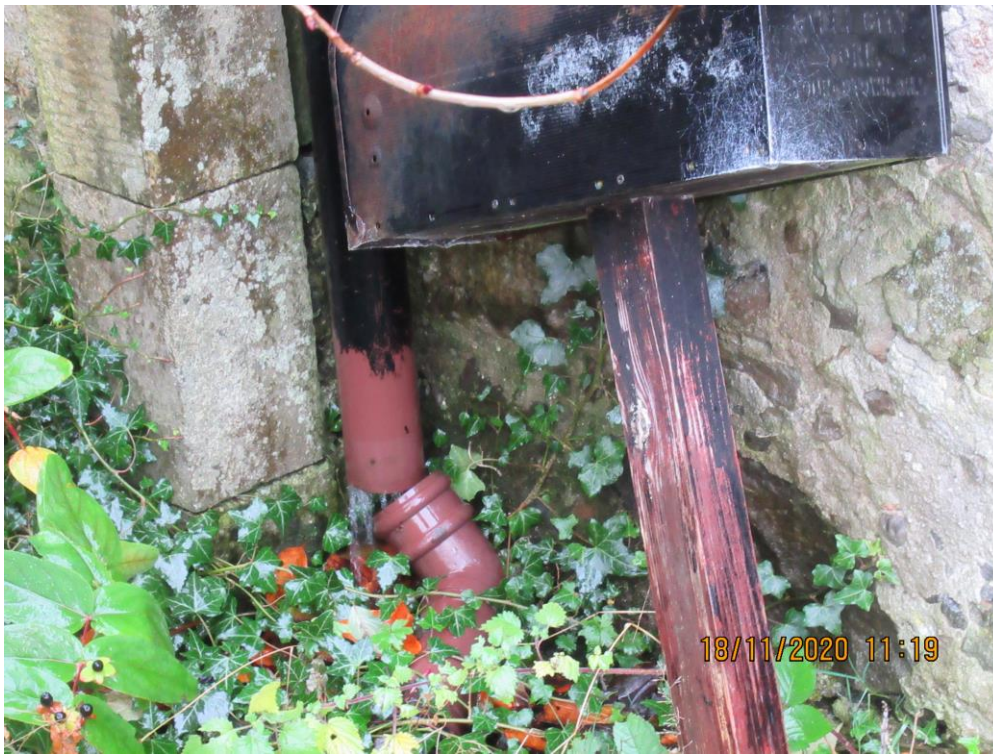
*This photo is of the same down pipe at the lower section. It shows the pipe being disconnected and flowing directly onto the ground.*

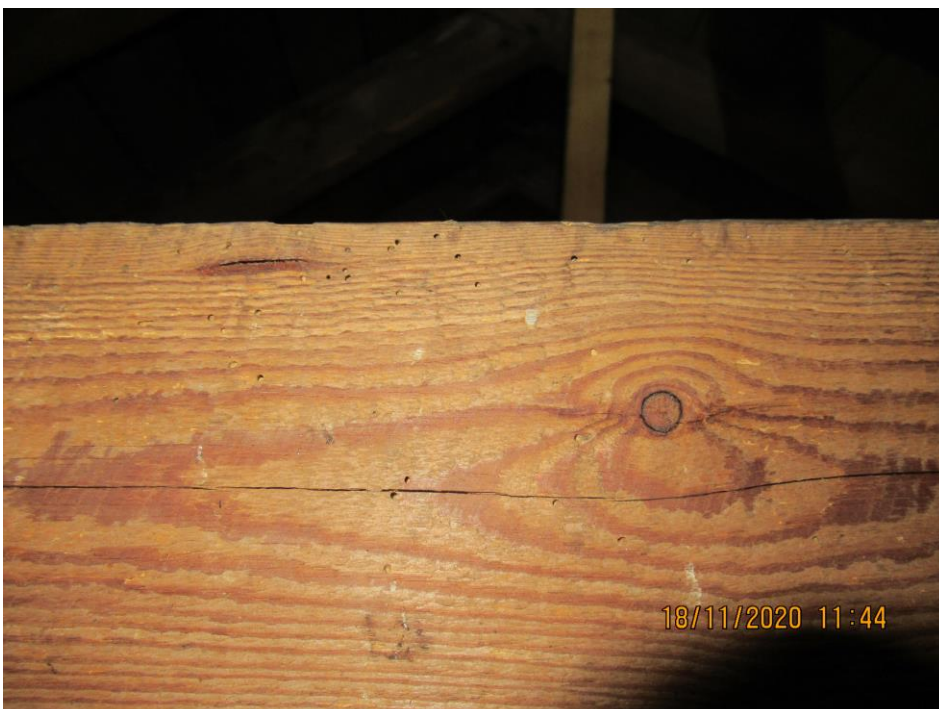
The older roof timbers were subject to woodworm infestations. In isolated areas the infestation was heavy to the extent where the outer layers are “honey-coombed”. This is often mistaken for decay. We can confirm that the infestations seen are inactive and we found no signs of timber decay that would warrant any form of remedial works.

*This photo shows a roof timber where the woodworm infestations are “inactive”. It is highly probable that woodworm treatments were carried out during the renovation of the roof.*

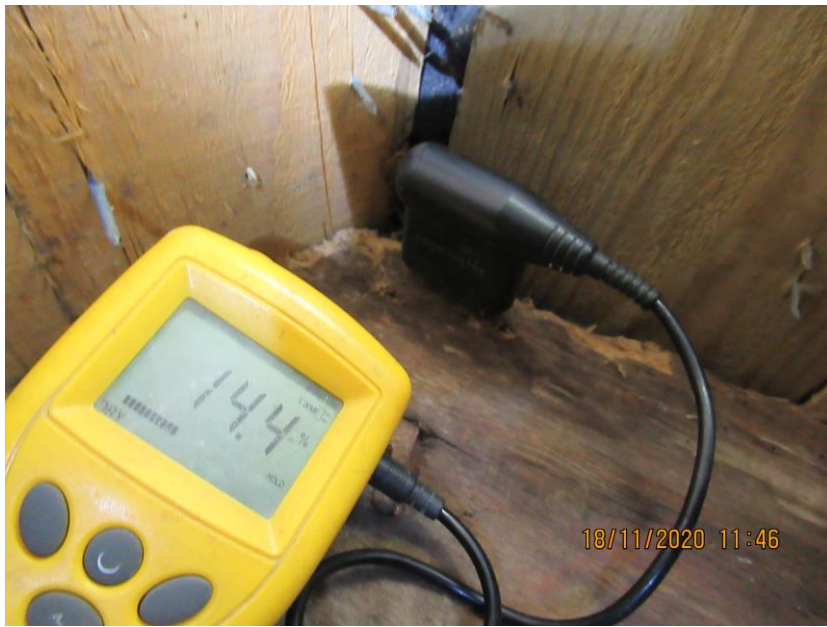
*This photo shows a rafter head that was badly affected by historic woodworm infestations and looks to be decayed, though we can confirm that there was no decay present. The moisture content reached 14.4% which is well within tolerable levels. It is when moisture contents reach mid 20%, we feel the need to further assess the situation.*

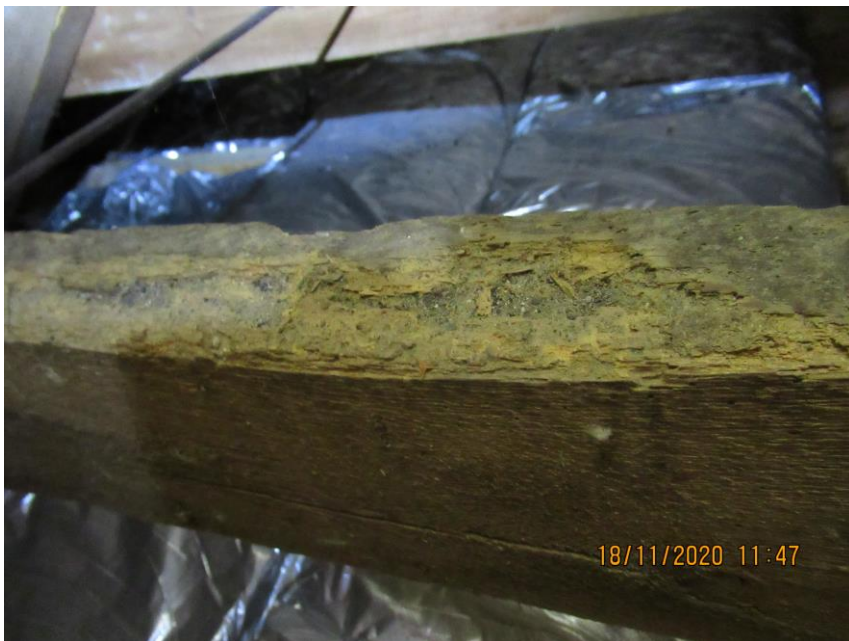
*This photo is of a ceiling tie timber that was badly affected by historic woodworm. However, it is only the outer layer that has slightly deteriorated and the timber remains sound and infestations are inactive.*

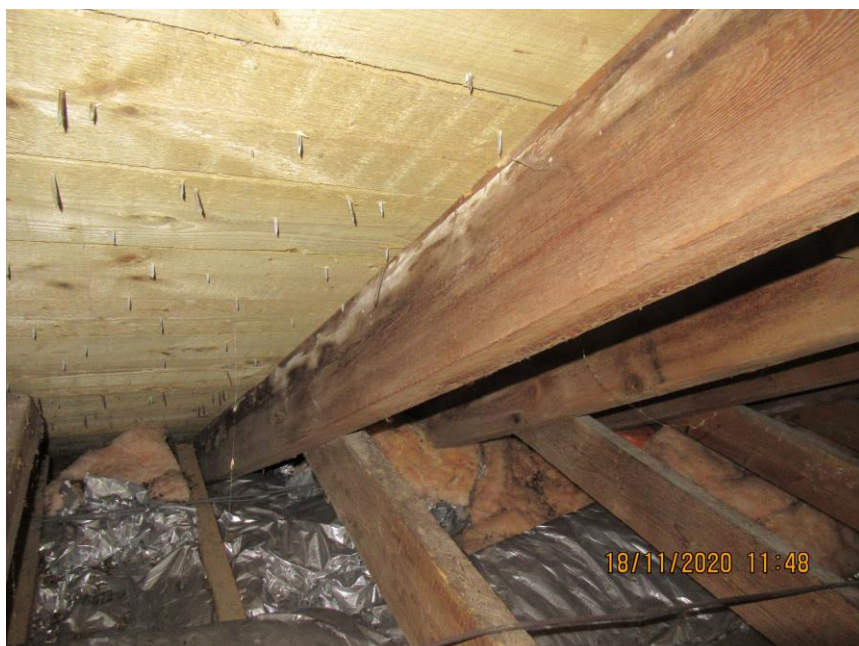
*This photo shows damp “staining” on the rafter. We confirm that this is historic “staining” and not active damp. New sarking boards can also be seen.*

Based on our observations within the roof void, we do not recommend any further treatments.

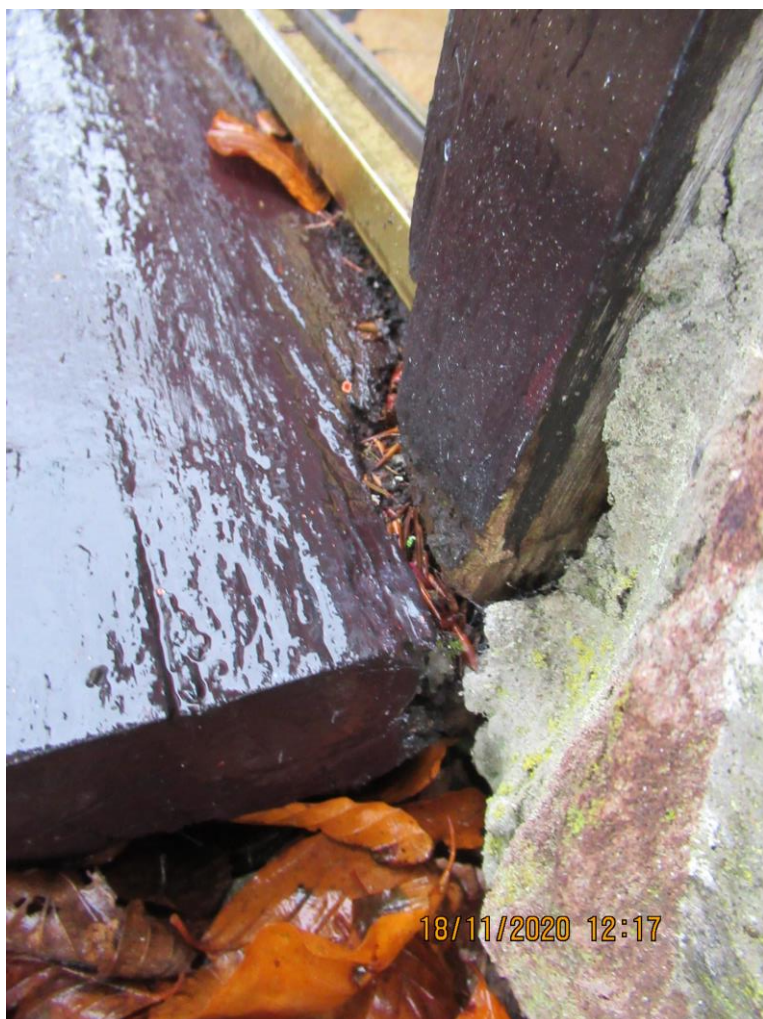
We noted slight to moderate moisture meter readings in and around the door ingoes of the front and back doors, though not to the extent that internal remedial works would be required. This may be a result of the door seals needing to be re-pointed combined with slight internal condensation. In particular, the front door bottom threshold is subject to surface decay as shown in the photo below.

*This photo shows the lower door post where it joins the threshold plate beginning to decay. The reason for this is due to design in the junction. You will also note the defective pointing where the door post meets the masonry.*

*We would recommend you employ a local tradesman to repair the timbers accordingly and have a defective pointing upgraded.*

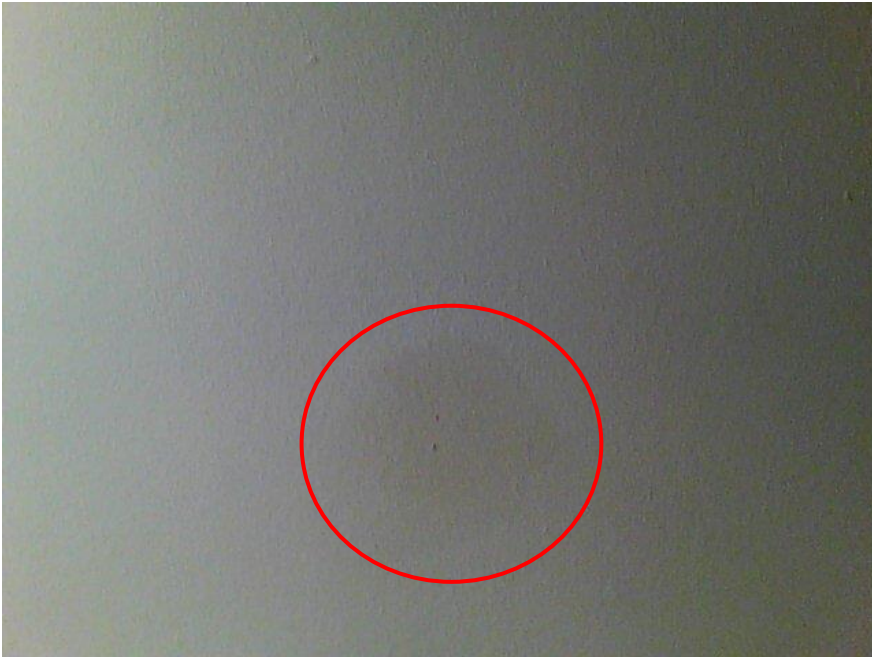
We noticed a small damp stain in the ceiling towards the front wall. This is a historic stain and not a damp patch.

*Historic damp stain in the ceiling*

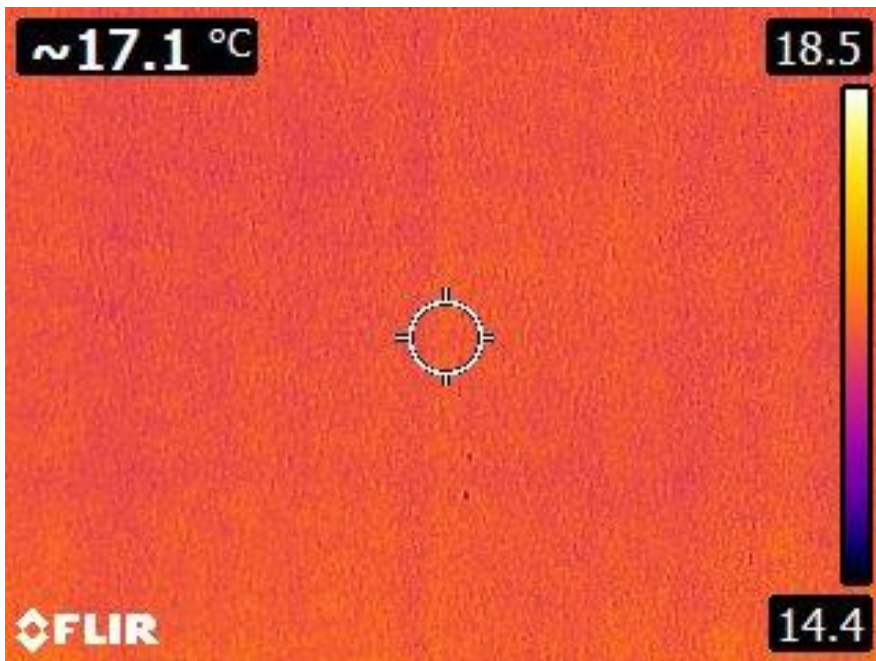
*This thermal image photo is a replica of the above photo. It demonstrates that the stain is not cold, which relates to it not being damp. If it were colder, then you would see a darker colour where the stain is.*

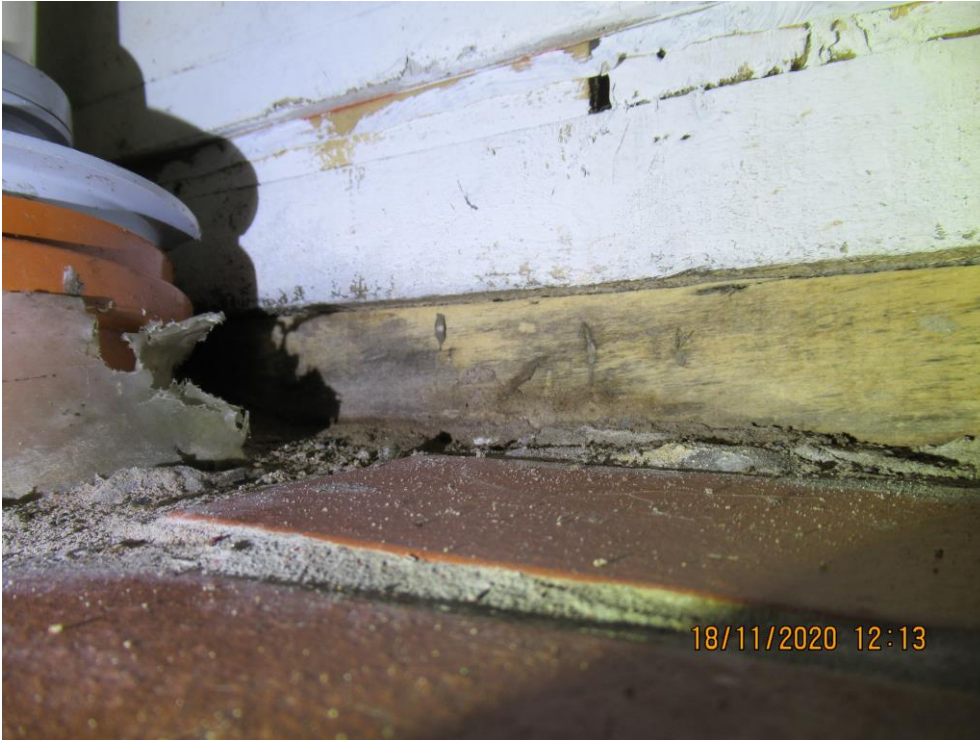
In the tall cupboard on the cooker wall where it abuts onto the rear wall, we noticed an isolated section of surface decay in the lower grounding timber. This appears to be historic and, in our opinion, does not pose a threat of manifesting into any colonisation or spread of decay. It is possible that this was a result of a leaking drainage pipe right next to the said area.

*Slight surface decay to the lower grounding timber.*

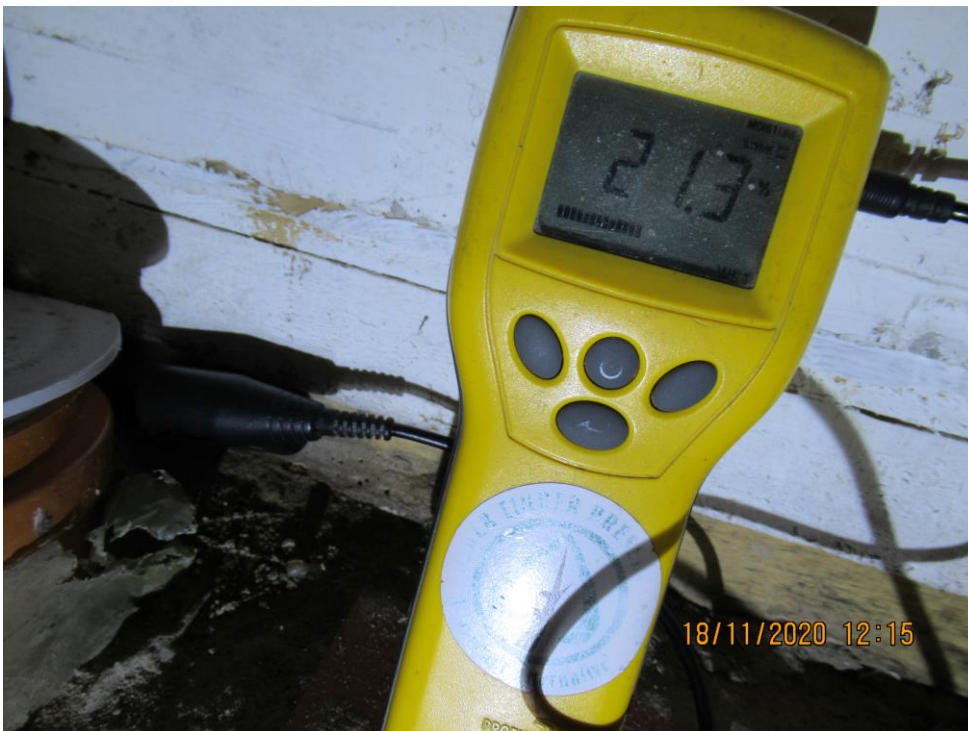
*Moisture readings of the isolated area reads 21.3%, which is still considered as "slight". If desired and as a precautionary measure, the affected area can be chiselled out and a preservative brush applied.*
