# Home Report

31 Millburn Court  
Inverness  
IV2 3PW

# single survey

## survey report on:

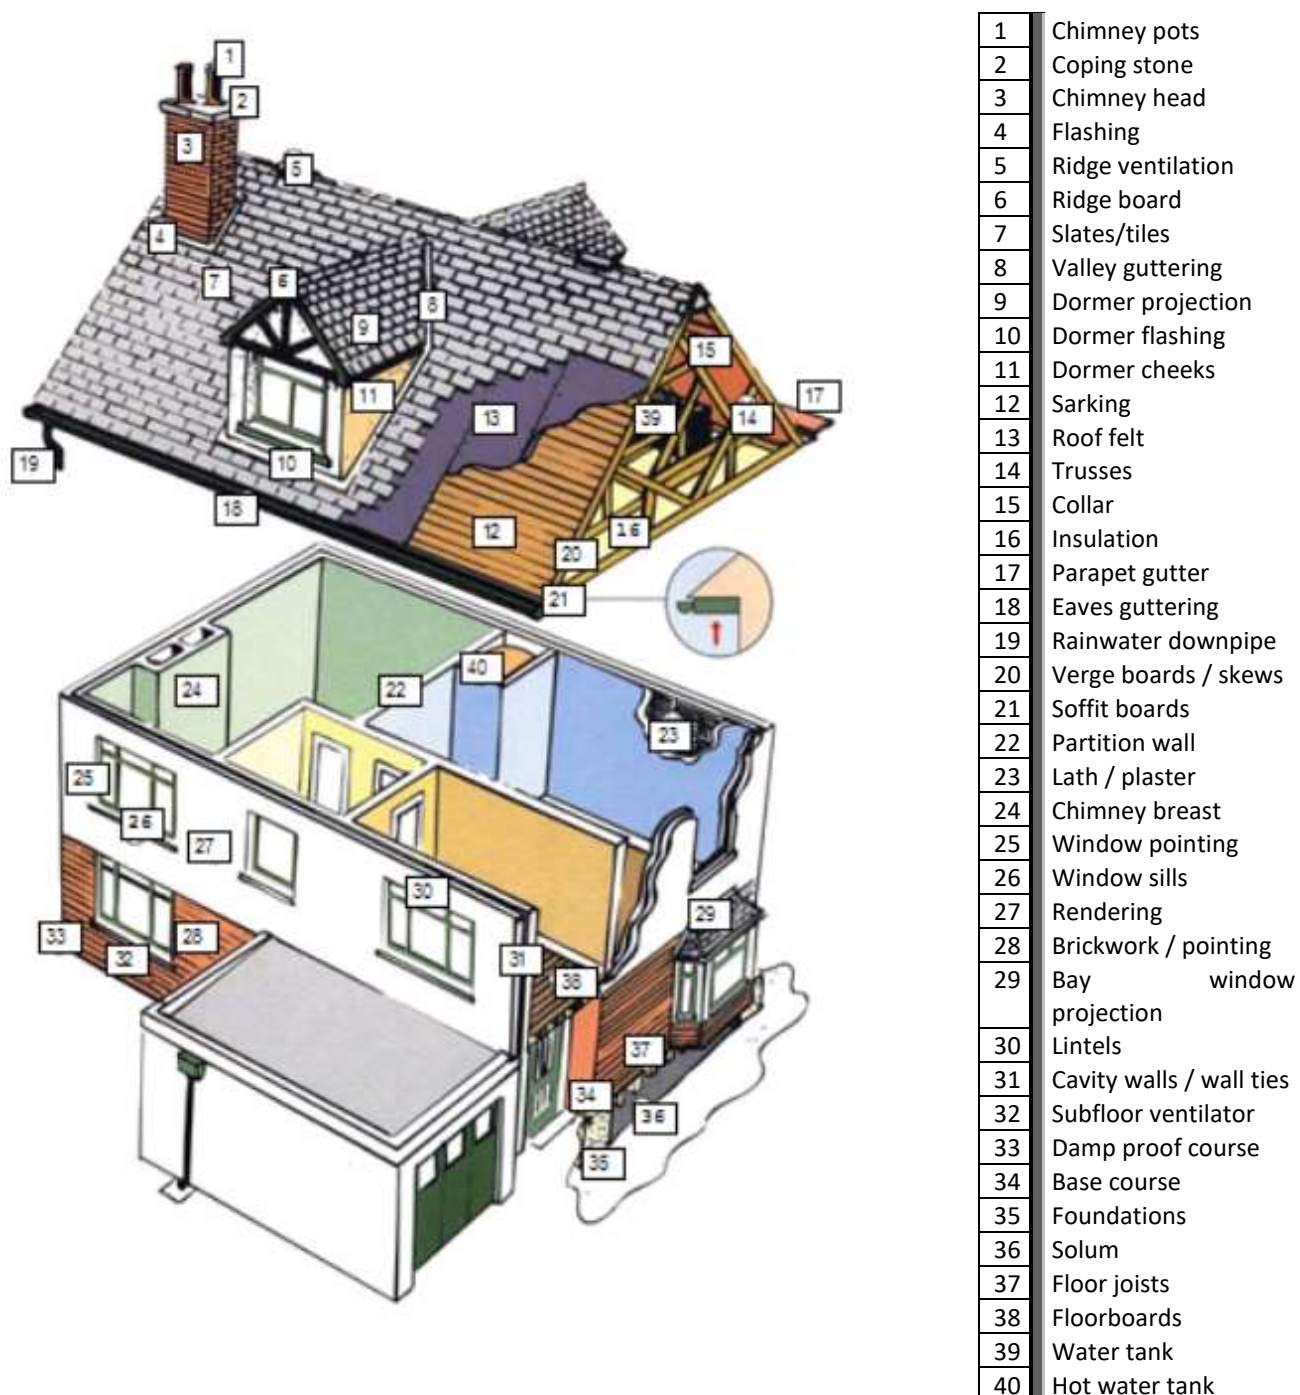
## Sectional Diagram showing elements of a typical house

Reference may be made in this report to some or all of the above component parts of the property. This diagram may assist you in locating and understanding these items.
