# Home Report

Ardselma  
Free Church Road  
Fort Augustus  
PH32 4DQ

# single survey

## survey report on:

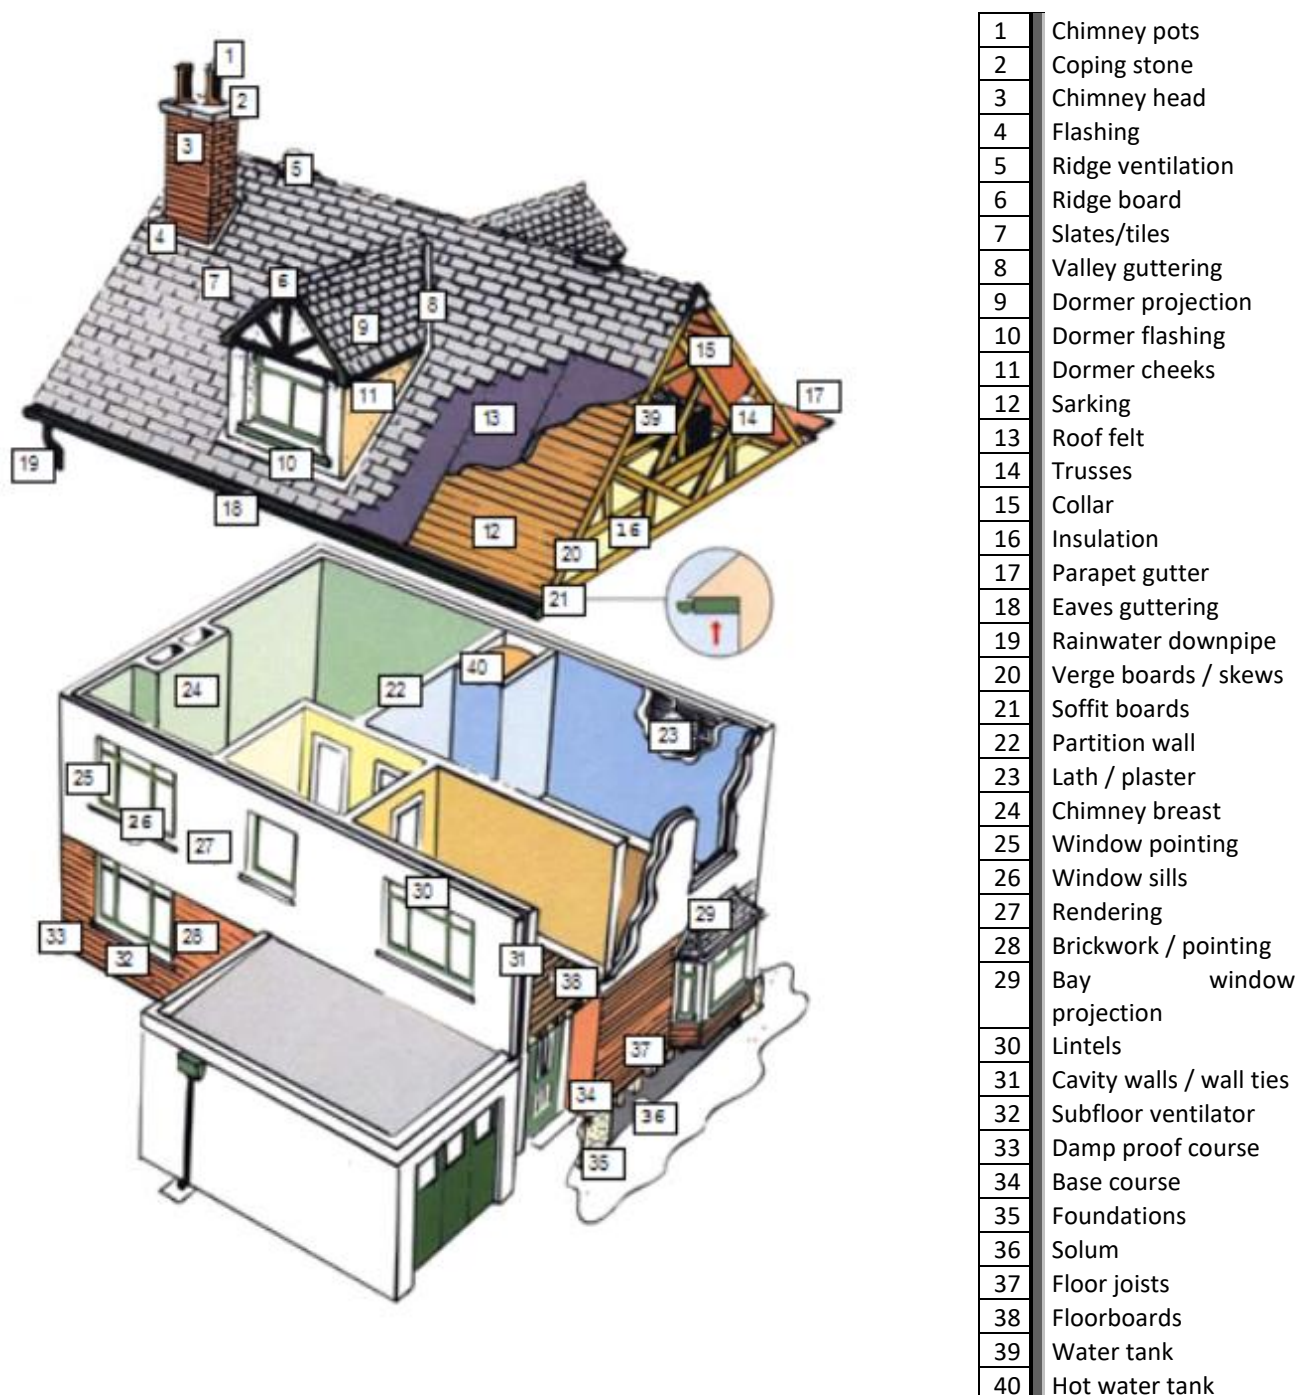
## Sectional Diagram showing elements of a typical house

Reference may be made in this report to some or all of the above component parts of the property. This diagram may assist you in locating and understanding these items.

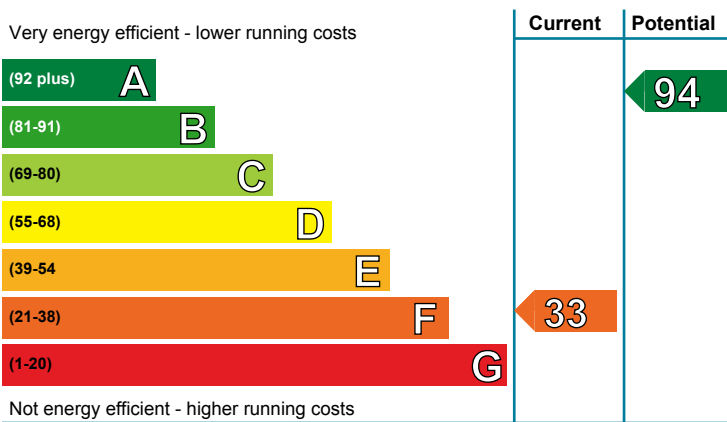
## Energy Efficiency Rating

This graph shows the current efficiency of your home, taking into account both energy efficiency and fuel costs. The higher this rating, the lower your fuel bills are likely to be.

Your current rating is **band F (33)**. The average rating for EPCs in Scotland is **band D (61)**.

The potential rating shows the effect of undertaking all of the improvement measures listed within your recommendations report.

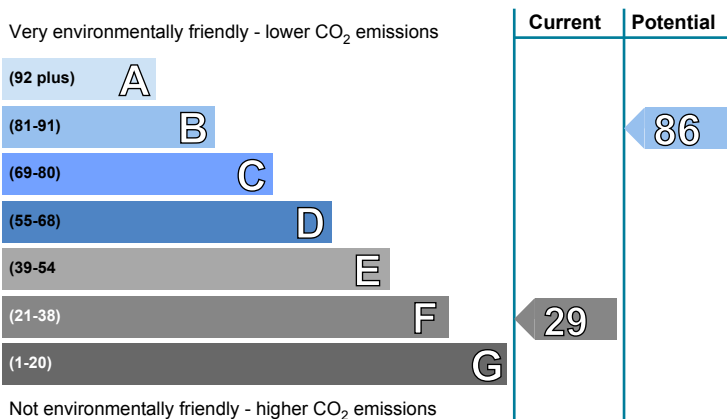
## Environmental Impact (CO<sub>2</sub>) Rating

This graph shows the effect of your home on the environment in terms of carbon dioxide (CO<sub>2</sub>) emissions. The higher the rating, the less impact it has on the environment.
