Home Report

11 Fettes Road Ardersier Inverness IV2 7UH

single survey

survey report on:

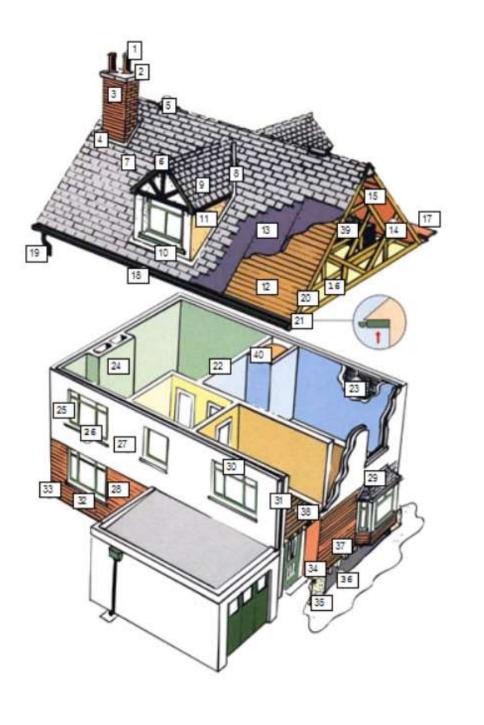
Sectional Diagram showing elements of a typical house

1	Chimney pots
2	Coping stone
3	Chimney head
4	Flashing
5	Ridge ventilation
6	Ridge board
7	Slates/tiles
8	Valley guttering
9	Dormer projection
10	Dormer flashing
11	Dormer cheeks
12	Sarking
13	Roof felt
14	Trusses
15	Collar
16	Insulation
17	Parapet gutter
18	Eaves guttering
19	Rainwater downpipe
20	Verge boards / skews
21	Soffit boards
22	Partition wall
23	Lath / plaster
24	Chimney breast
25	Window pointing
26	Window sills
27	Rendering
28	Brickwork / pointing
29	Bay window
	projection
30	Lintels
31	Cavity walls / wall ties
32	Subfloor ventilator
33	Damp proof course
34	Base course
35	Foundations
36	Solum
37	Floor joists
38	Floorboards
39	Water tank
40	Hot water tank
