2 ST FERGUS DRIVE
INVERNESS
IV3 5AN

Home Report

2 ST FERGUS DRIVE, INVERNESS, IV3 5AN

Dwelling type: Semi-detached house
Date of assessment: 20 April 2021
Date of certificate: 21 April 2021
Total floor area: 91 m²
Primary Energy Indicator: 401 kWh/m²/year

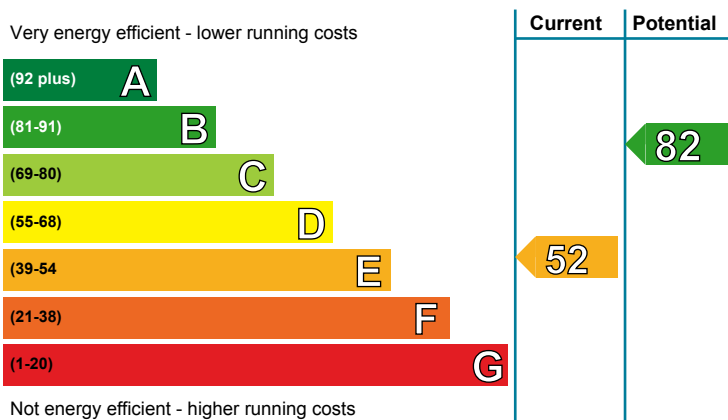
Energy Efficiency Rating

This graph shows the current efficiency of your home, taking into account both energy efficiency and fuel costs. The higher this rating, the lower your fuel bills are likely to be.

Your current rating is **band E (52)**. The average rating for EPCs in Scotland is **band D (61)**.

The potential rating shows the effect of undertaking all of the improvement measures listed within your recommendations report.

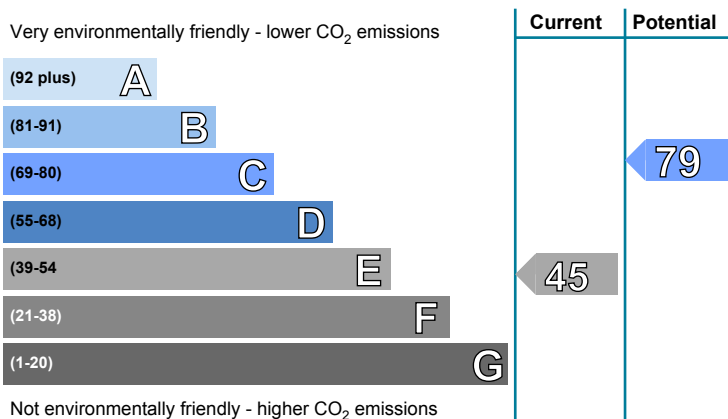
Environmental Impact (CO₂) Rating

This graph shows the effect of your home on the environment in terms of carbon dioxide (CO₂) emissions. The higher the rating, the less impact it has on the environment.

Your current rating is **band E (45)**. The average rating for EPCs in Scotland is **band D (59)**.

The potential rating shows the effect of undertaking all of the improvement measures listed within your recommendations report.
