# HOME REPORT

MARKET STANCE

NAIRN  
IV12 5SB

# Single Survey

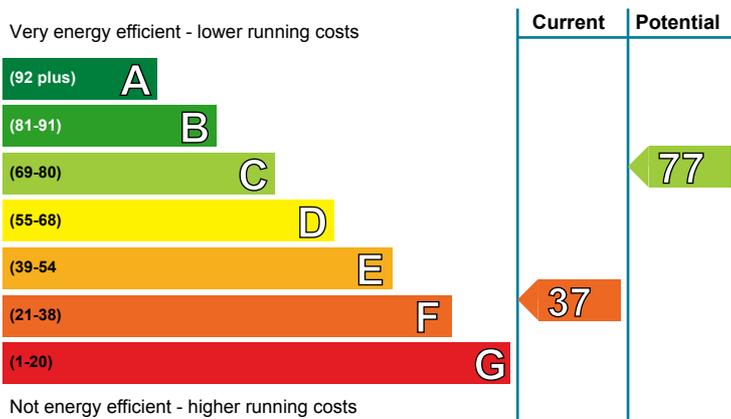
## Energy Efficiency Rating

This graph shows the current efficiency of your home, taking into account both energy efficiency and fuel costs. The higher this rating, the lower your fuel bills are likely to be.

Your current rating is **band F (37)**. The average rating for EPCs in Scotland is **band D (61)**.

The potential rating shows the effect of undertaking all of the improvement measures listed within your recommendations report.

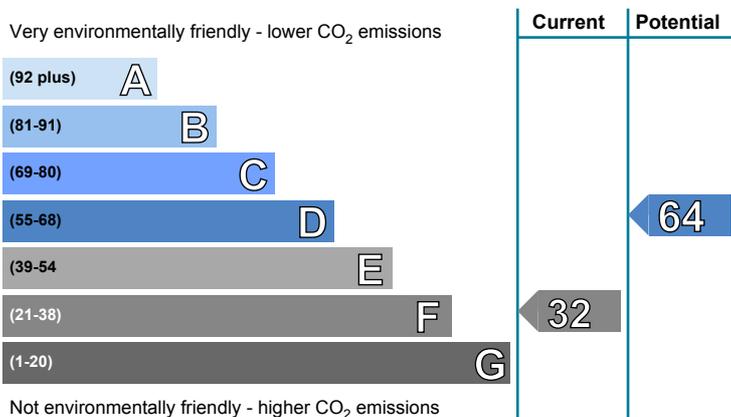
## Environmental Impact (CO<sub>2</sub>) Rating

This graph shows the effect of your home on the environment in terms of carbon dioxide (CO<sub>2</sub>) emissions. The higher the rating, the less impact it has on the environment.

Your current rating is **band F (32)**. The average rating for EPCs in Scotland is **band D (59)**.

The potential rating shows the effect of undertaking all of the improvement measures listed within your recommendations report.
