HOME REPORT

4 PARK BUILDINGS
PARK STREET
NAIRN
IV12 4PJ

Energy Performance Certificate (EPC)

SINGLE SURVEY

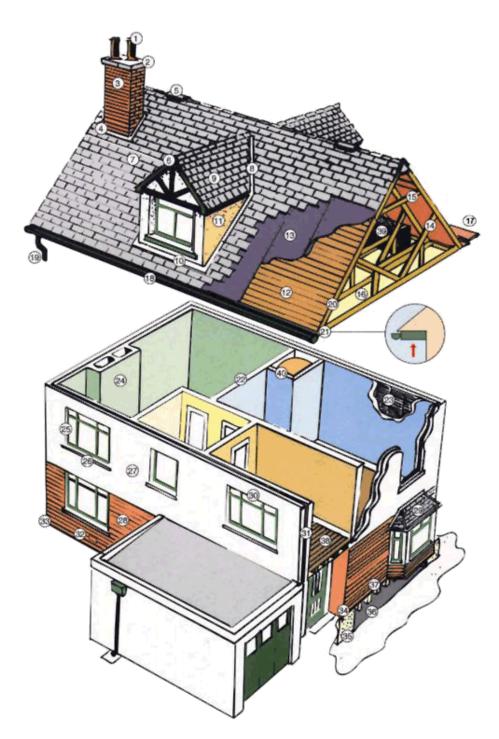
Sectional Diagram showing elements of a typical house

Reference may be made in this report to some or all of the above component parts of the property. This diagram may assist you in locating and understanding these items.

- 1) Chimney pots
- 2) Coping stone
- 3) Chimney head
- 4 Flashing
- 5 Ridge ventilation
- 6) Ridge board
- 7) Slates / tiles
- 8 Valley guttering
- 9) Dormer projection
- 10) Dormer flashing
- 11) Dormer cheeks
- 12) Sarking
- (13) Roof felt
- (14) Trusses
- (15) Collar
- 16) Insulation
- 17) Parapet gutter
- (18) Eaves guttering
- (19) Rainwater downpipe
- 20) Verge boards /skews
- 21) Soffit boards
- 22) Partition wall
- 23) Lath / plaster
- 24) Chimney breast
- (25) Window pointing
 - Window sills
- 27) Rendering
- (28) Brickwork / pointing
- 29) Bay window projection
- 30 Lintels
- (31) Cavity walls / wall ties
- 32) Subfloor ventilator
- 33) Damp proof course
- 34) Base course
- 35) Foundations
- 36) Solum
- Floor joists
- 38) Floorboards
- (39) Water tank
- 40 Hot water tank
